BUILDING-STRUCTURE INVENTORY FORM

1. BUILDING NAME(S): _____
2. COUNTY: Monroe TOWN/CITY: Greece VILLAGE: ---
3. STREET LOCATION: 136 Edgemere Drive
4. OWNERSHIP: a. public ☐ b. private ☒
5. PRESENT OWNER: Geraldine Campbell ADDRESS: (same) Rochester, NY 14612
6. USE: Original: residence Present: residence
7. ACCESSIBILITY TO PUBLIC: Exterior visible from public road: Yes ☒ No ☐
Interior accessible: Explain private residence

Town of Greece Historic Sites Survey
Monroe County, New York
136 Edgemere Drive
page 3

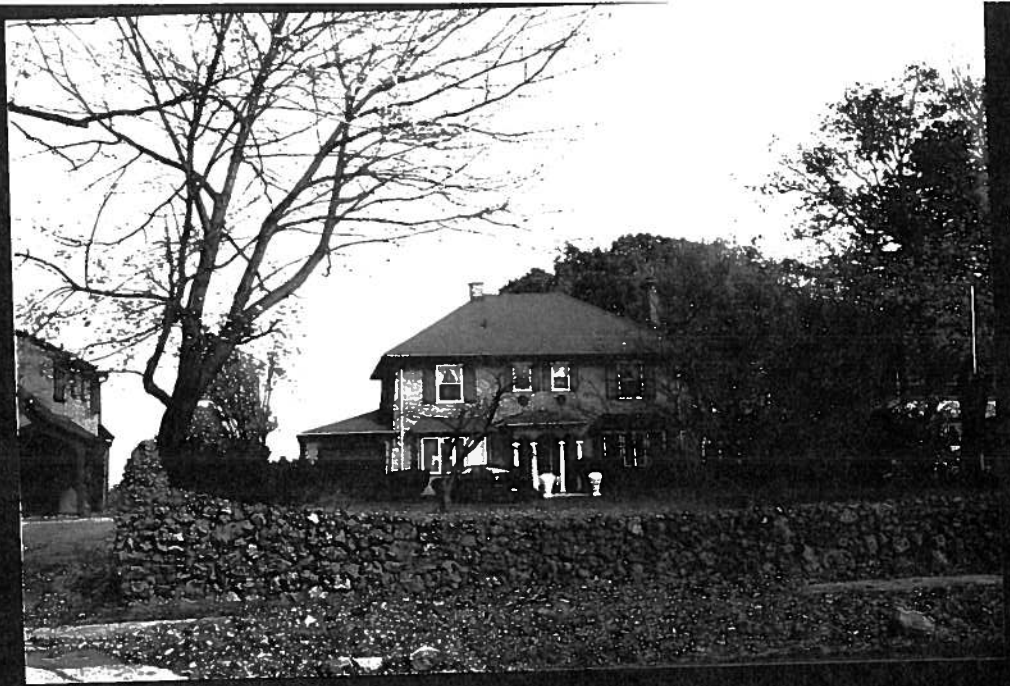
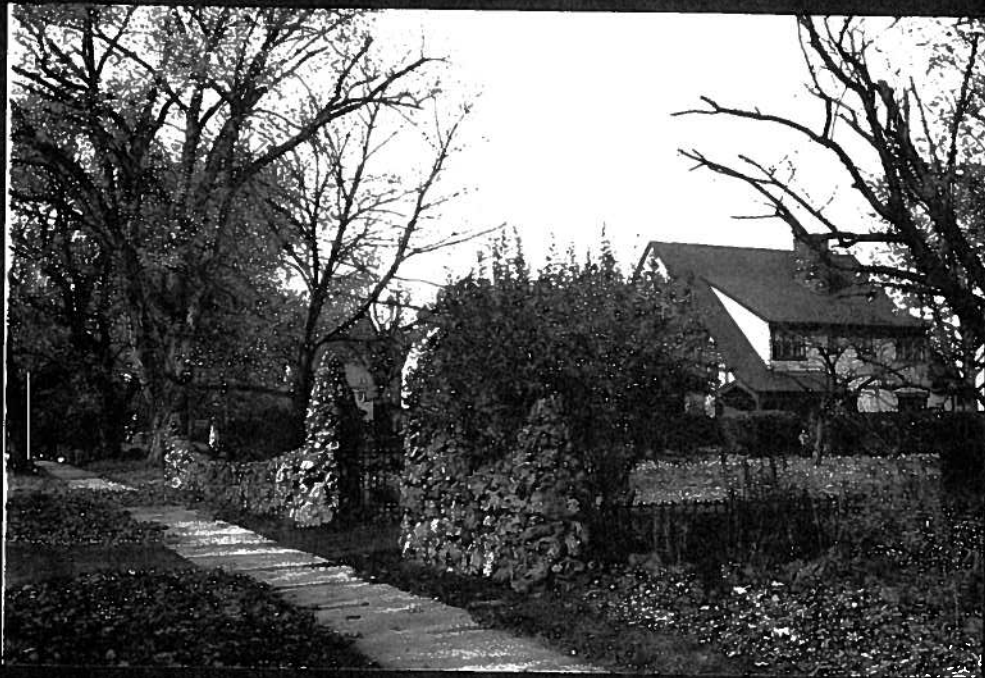
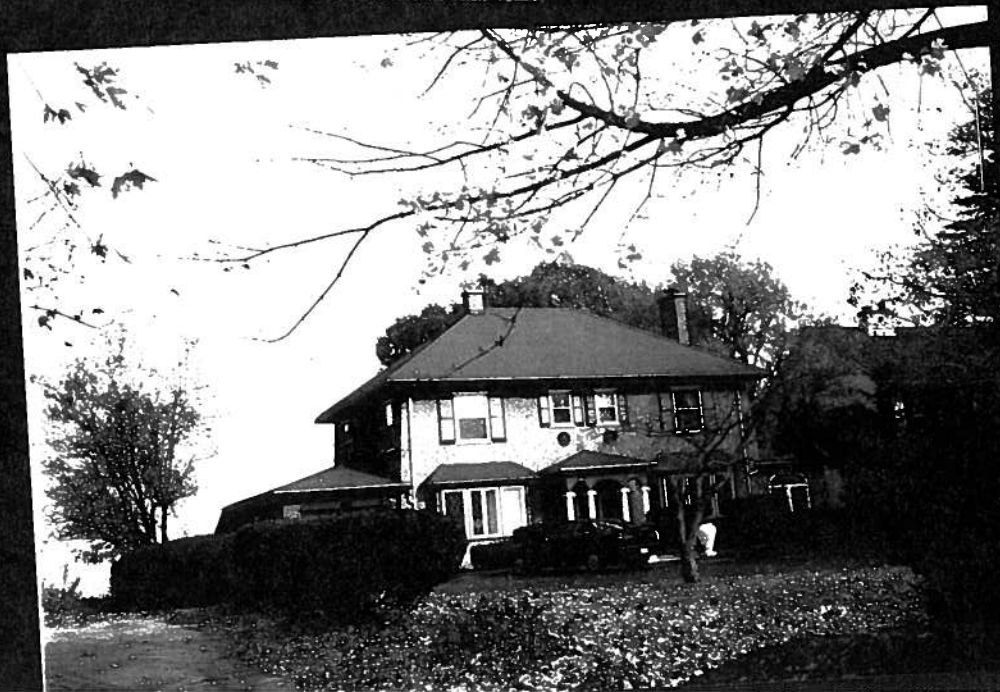
12. PHOTO:

"The front stone wall is the best part of this house - it's a wonderful wall. The house is stucco with those battered (angled) walls. Actually, the portico is quite nice, but the facade is a bit crowded with the two bay windows and the portico; looks kind of congested. The portico, however, is quite nice and, of course, it's a great site. This can safely make it into the 'red' category." P.Malo

18. This c. 1930 - 1934 Colonial Revival house is a two-and-one-half-story, hipped-roof residence featuring a rectangular plan, stucco veneer and asphalt shingle roof. A tall brick chimney is located on the east slope of the hipped roof and a shorter brick chimney is located on the west peak of the roof.

The symmetrical facade features regular fenestration of 1/1, double-hung and casement sash; both sash have diamond-paned glass. The upper windows have louvered shutters. The center entrance is covered by a low-pitched, hipped roof. The porch features paired columns with Ionic capitals, which are topped by a frieze band of round arches (with stucco veneer). Two round, ceramic, decorative medallions with bas relief design are located in the wall above the entrance porch.

A one-story east wing includes a large window with paired casement sash and a curved fan light above. A one-car garage with stucco veneer is attached to the west elevation.

The yard includes a number of deciduous trees and coniferous shrubs. A wide, circular driveway is located in front of the house. A distinctive stone wall with conical stone posts extends along the front of the lawn by the public sidewalk. The stone wall also includes curved-top, wrought iron entrance gates with straight balusters and scroll brackets.
